# Debris/Ice/TPS Assessment And Photographic Analysis For Shuttle Mission STS-41

(NASA-TM-103814) DEBRIS/ICE/TPS ASSESSMENT  
AND PHOTOGRAPHIC ANALYSIS FOR SHUTTLE  
MISSION STS-41 (NASA) 151 p CSCL 22B

DEBRIS/ICE/TPS ASSESSMENT  
AND  
PHOTOGRAPHIC ANALYSIS  
OF  
SHUTTLE MISSION STS-41

October 6, 1990

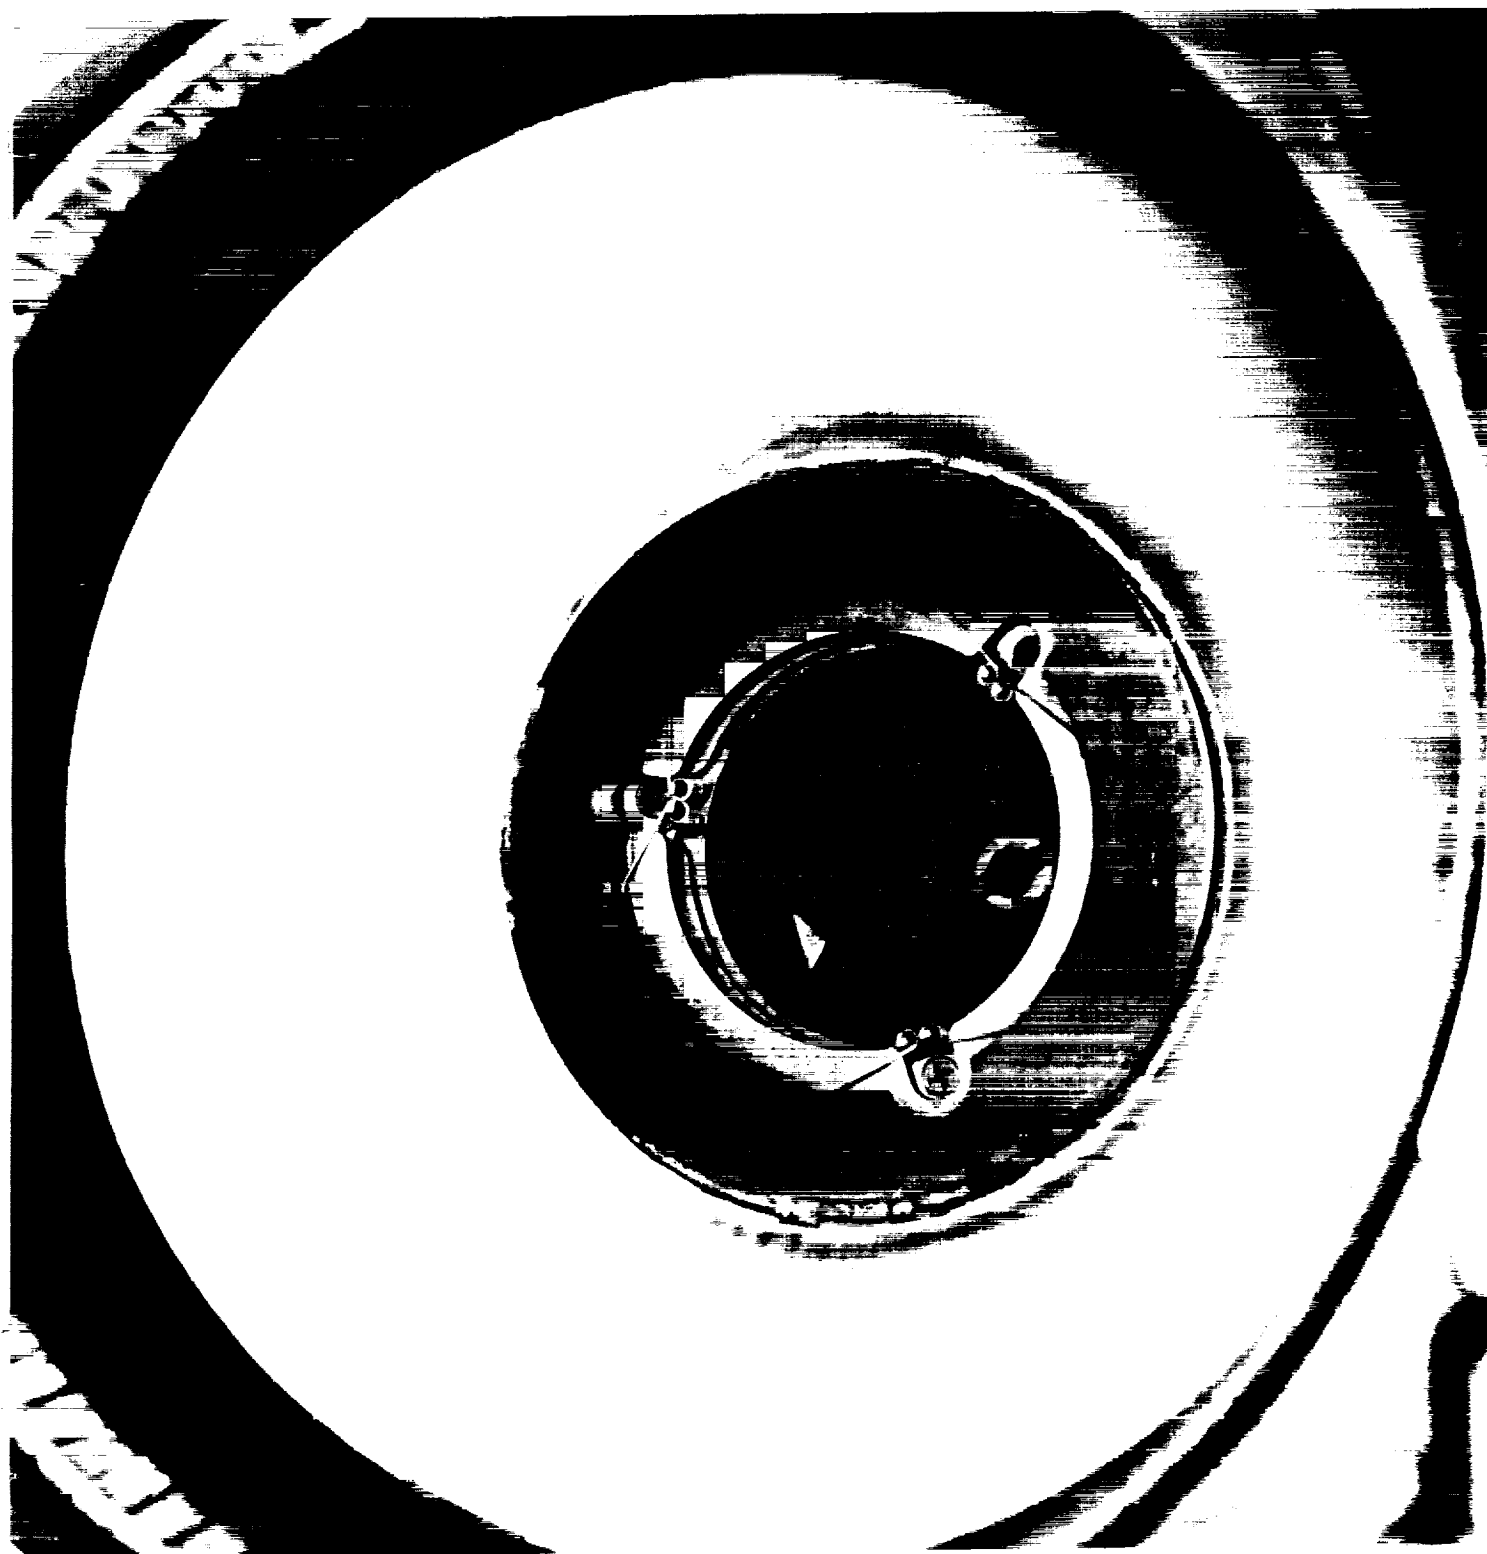
EO-2 separation fitting debris container plunger was jammed  
open by frangible nut half

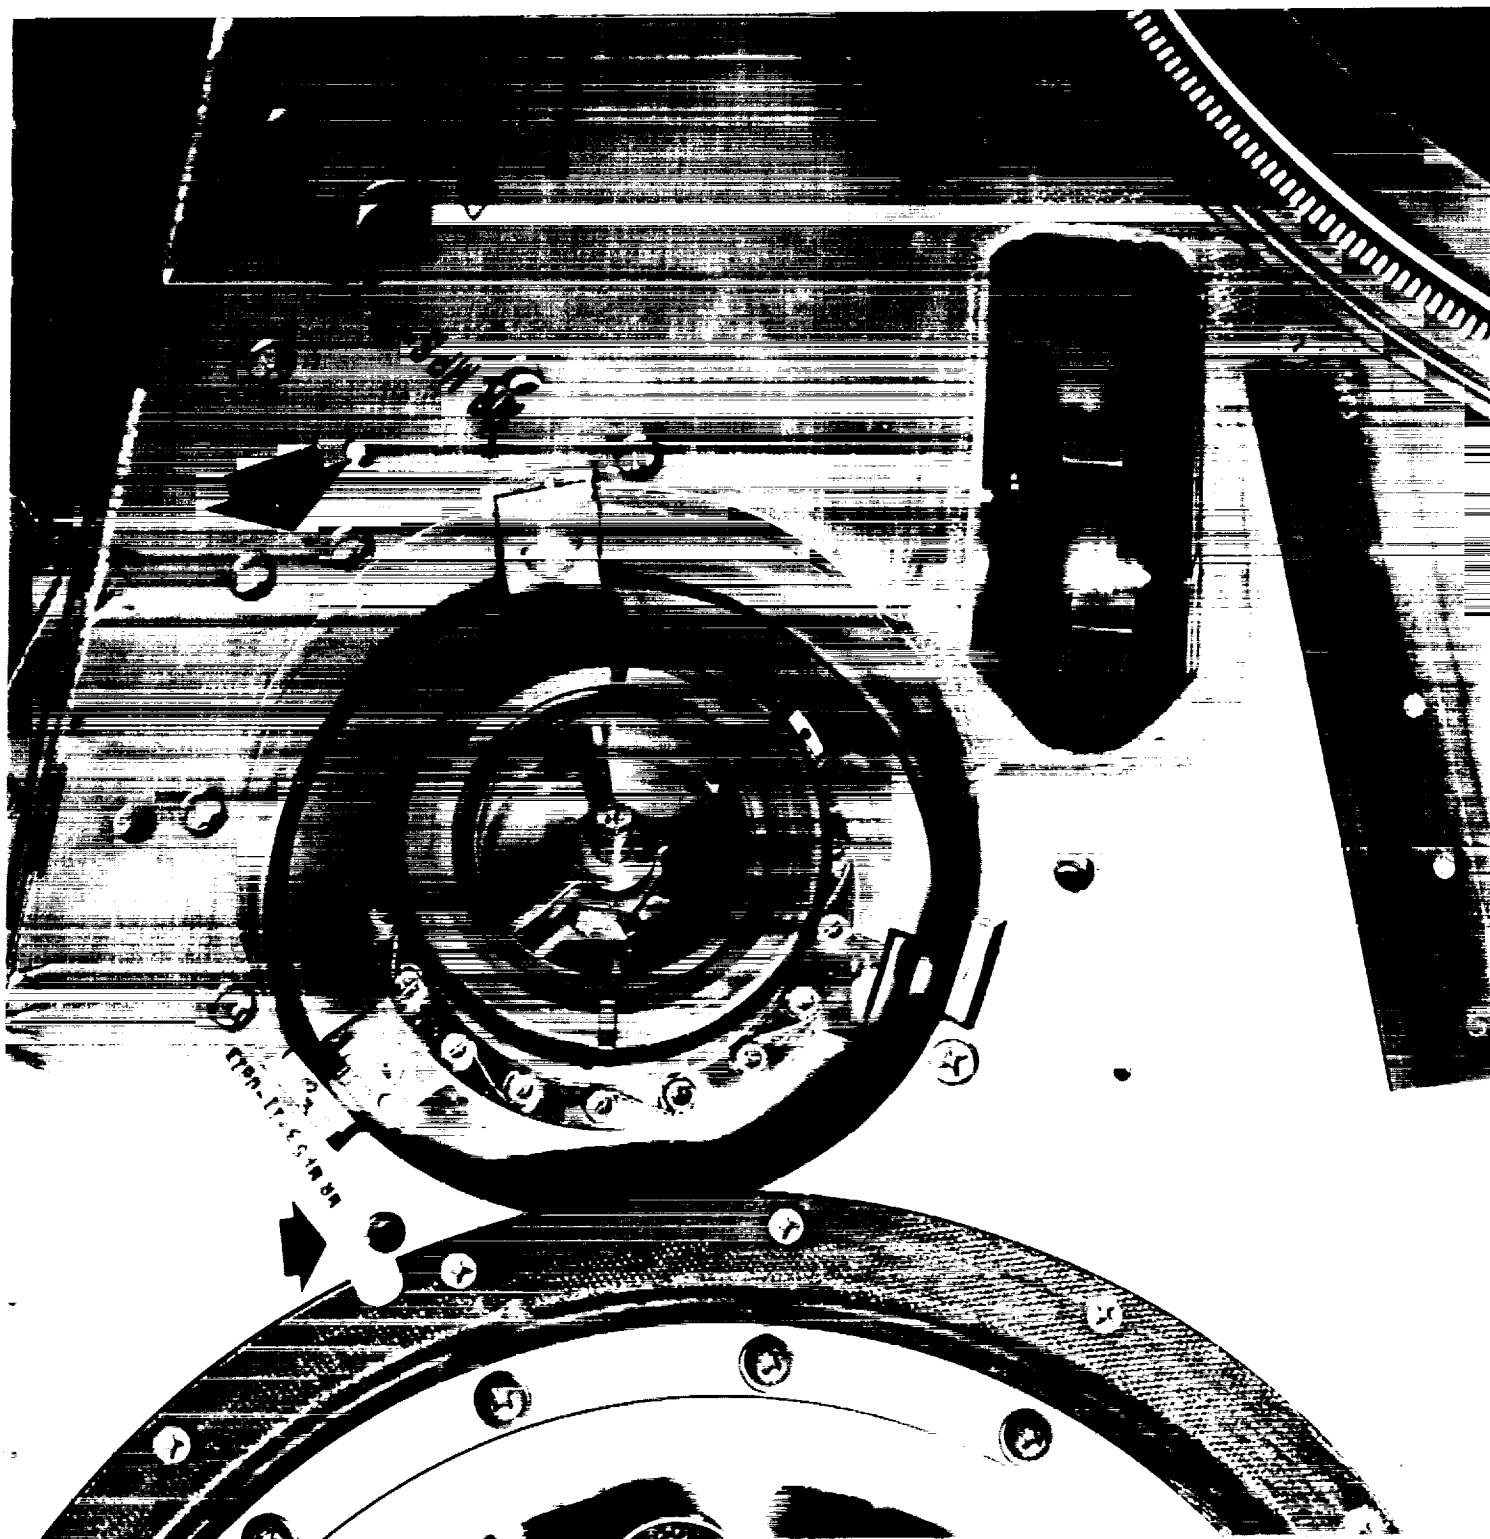
L02 2-inch press line and attaching fasteners had been pulled away from the umbilical plate. Some fasteners were missing.

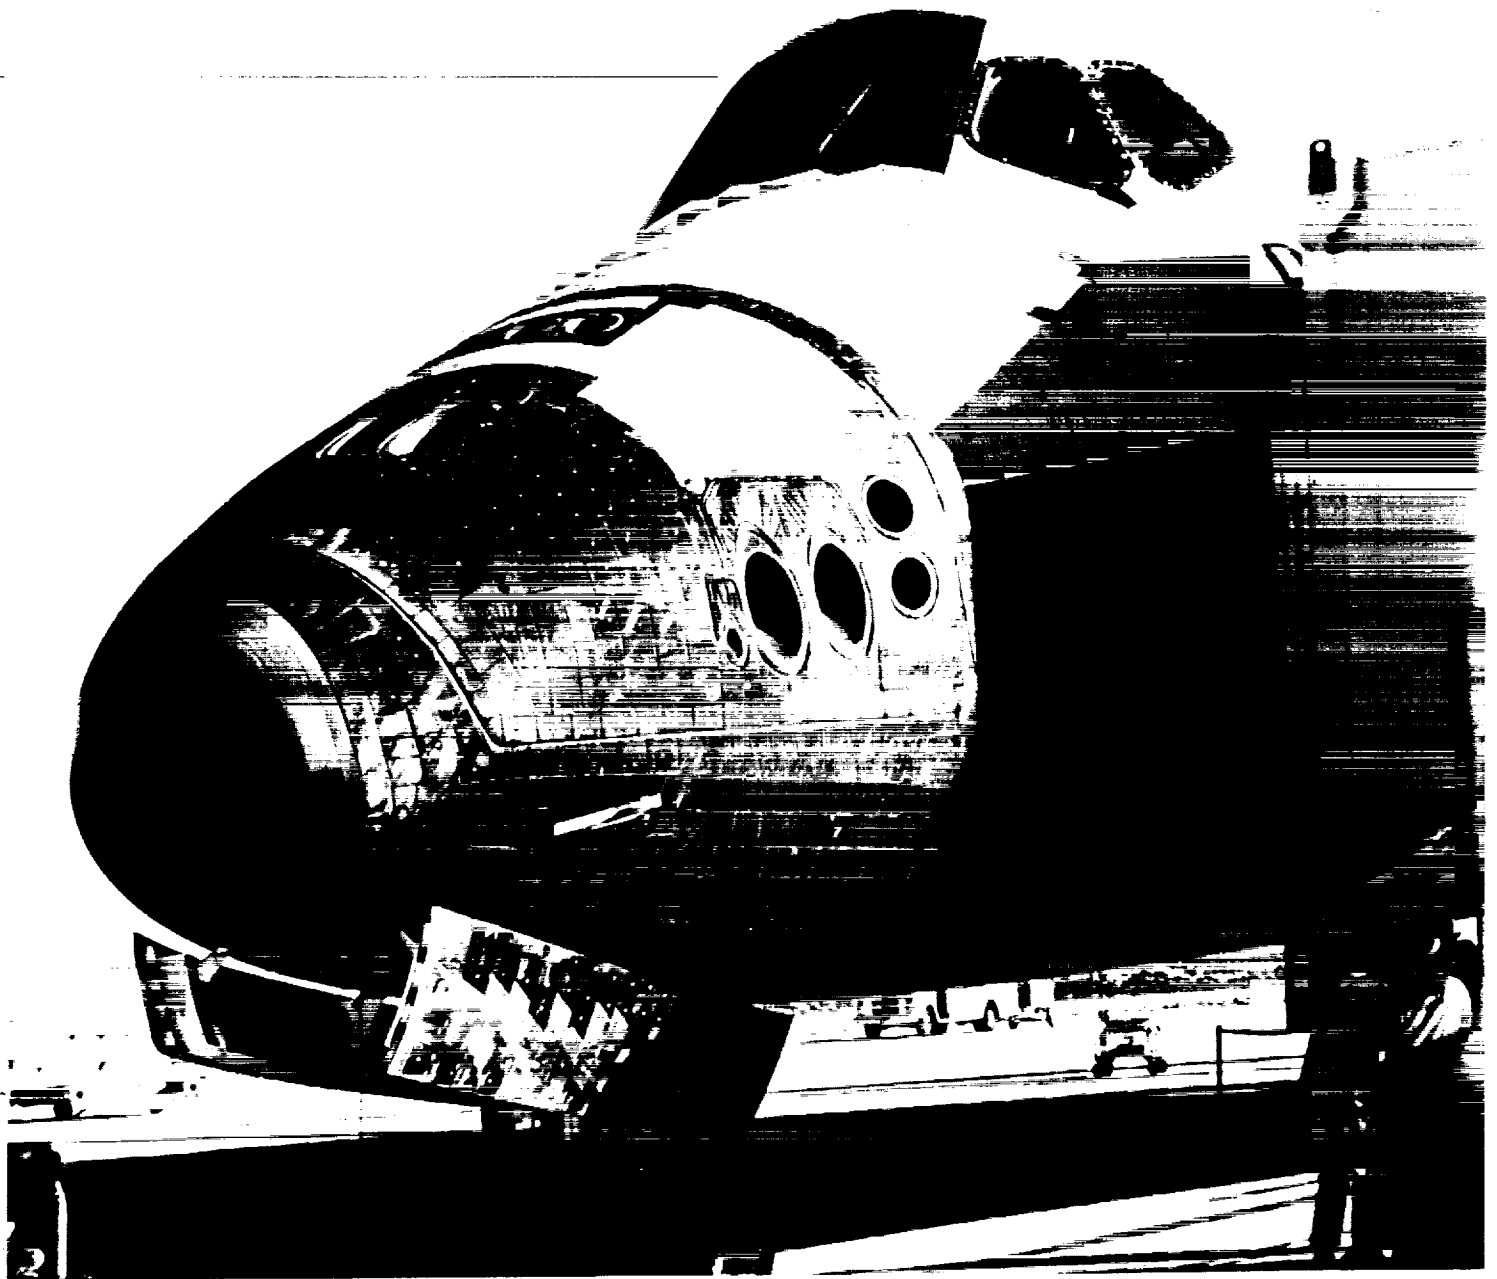
MMH tank relief vent on the LH side of the Forward RCS  
module sustained an on-orbit high velocity impact
